DOT/FAA/CT-94/56

# Characterization of Corrosion and Development of a Breadboard Model of a D Sight Aircraft Inspection System: Phase I

August 1994

Final Report

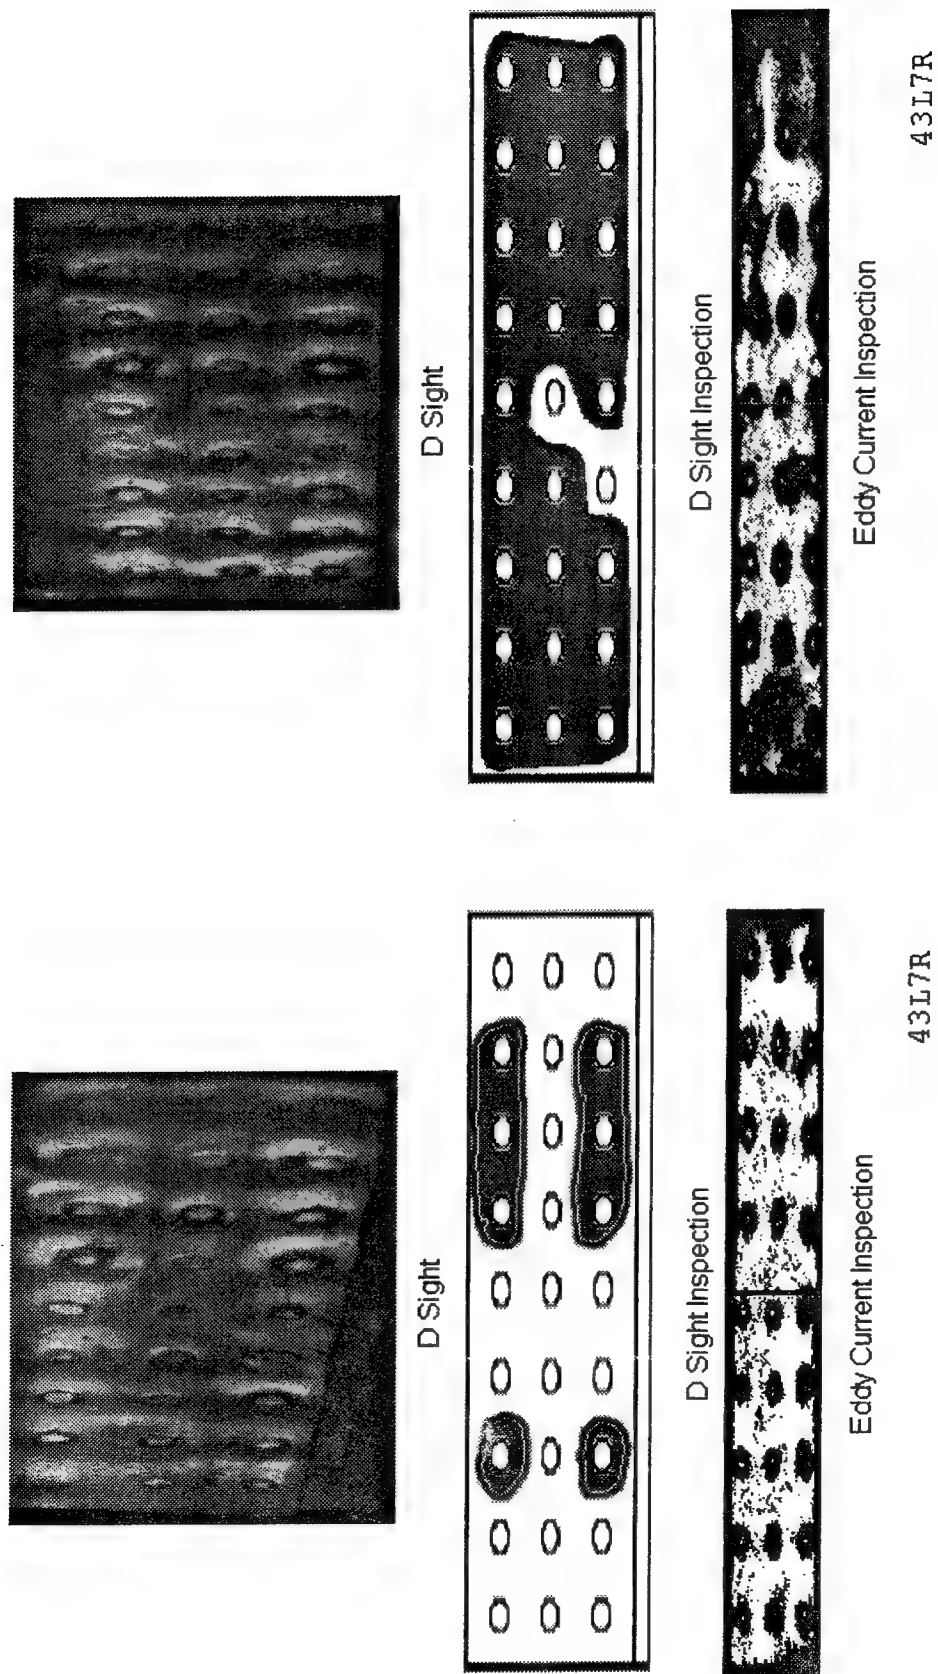
Specime	D Sight result	Shadow Moiré	Eddy Current
56T21A	light corrosion	light corrosion	rivets too close for complete inspection
46L3E	mostly middle row but also light corrosion in top and bottom	mostly middle row (0.013")	no indication
43L6	all corroded	all corroded but less in top row (0.007")	all corroded (0.007")
51L2	bottom, middle and top rows corroded	bottom, middle but less in the top row (0.005")	weak indication in all rows
46L4C	top, middle and bottom but not everywhere	top, middle and bottom but not everywhere (0.010")	some corrosion indication
46L4A	all corroded	all but light (0.005")	some areas mostly middle row
46L3C	all corroded	all corroded (0.007")	most areas corroded
46L3A	middle and top row light corrosion	middle and top light corrosion (0.003-4")	no indication
43L7R	all corroded	all corroded (0.007")	little corrosion

Figure 7.2 Specimen 43L7R pre- and post-corrosion inspection results. D Sight images, D Sight and Eddy Current corrosion maps.

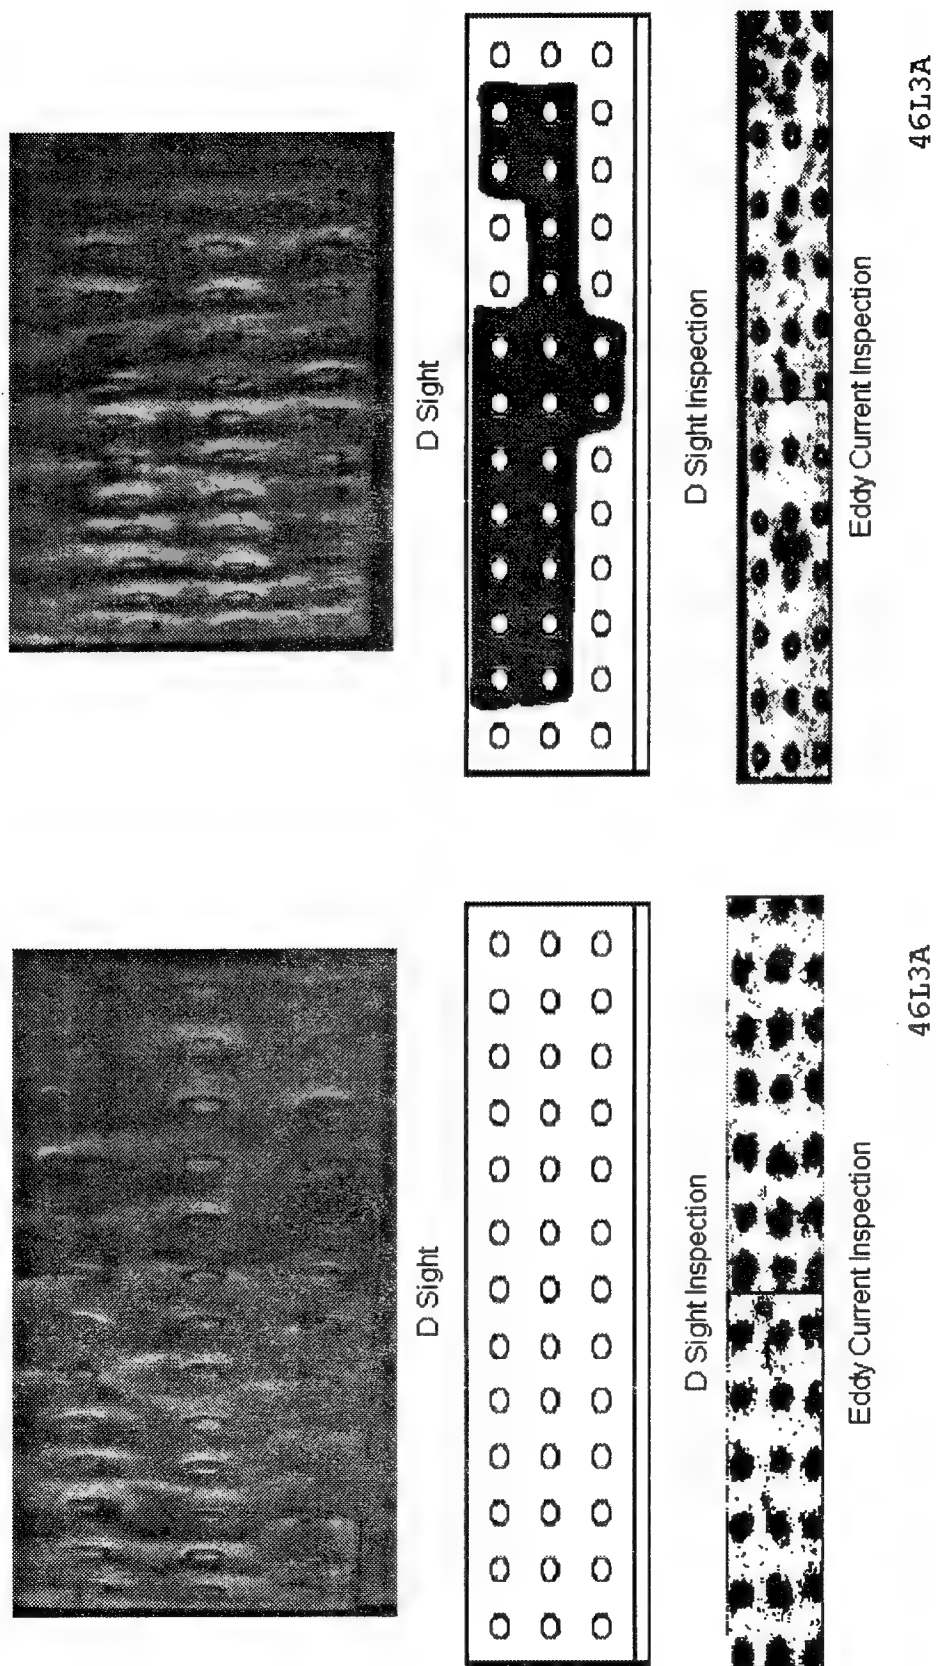
**Figure 7.3** Specimen 46L3A pre- and post-corrosion inspection results. D Sight images, D Sight and Eddy Current corrosion maps.

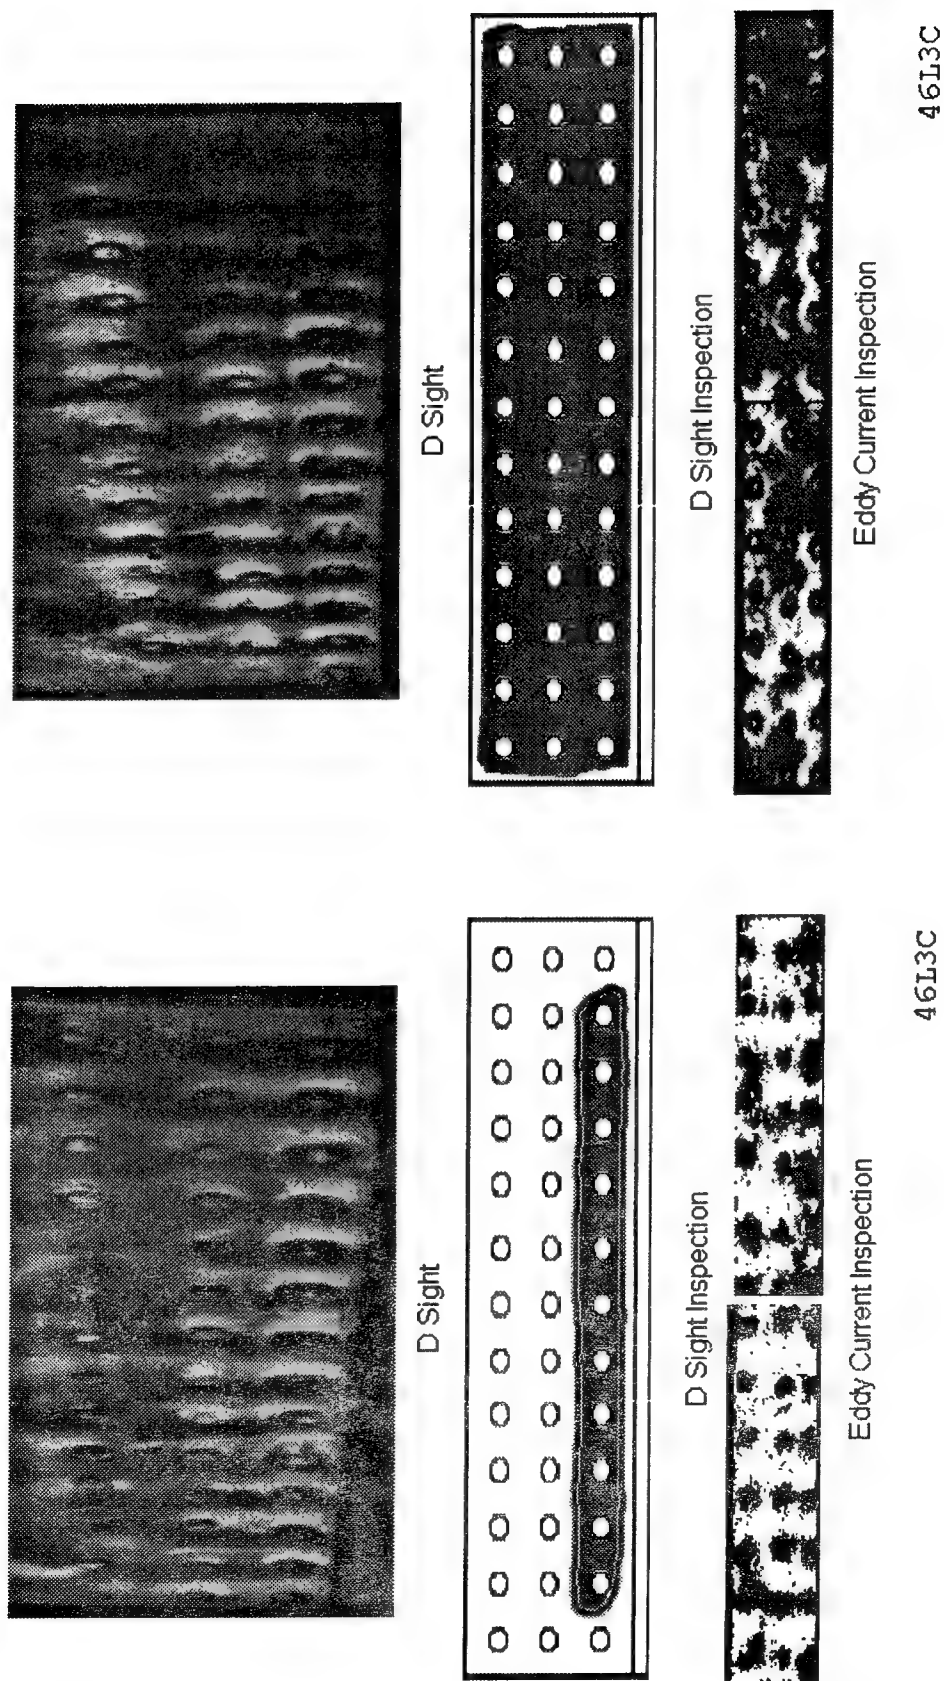
**Figure 7.4** Specimen 46L3C pre- and post-corrosion inspection results. D Sight images, D Sight and Eddy Current corrosion maps.

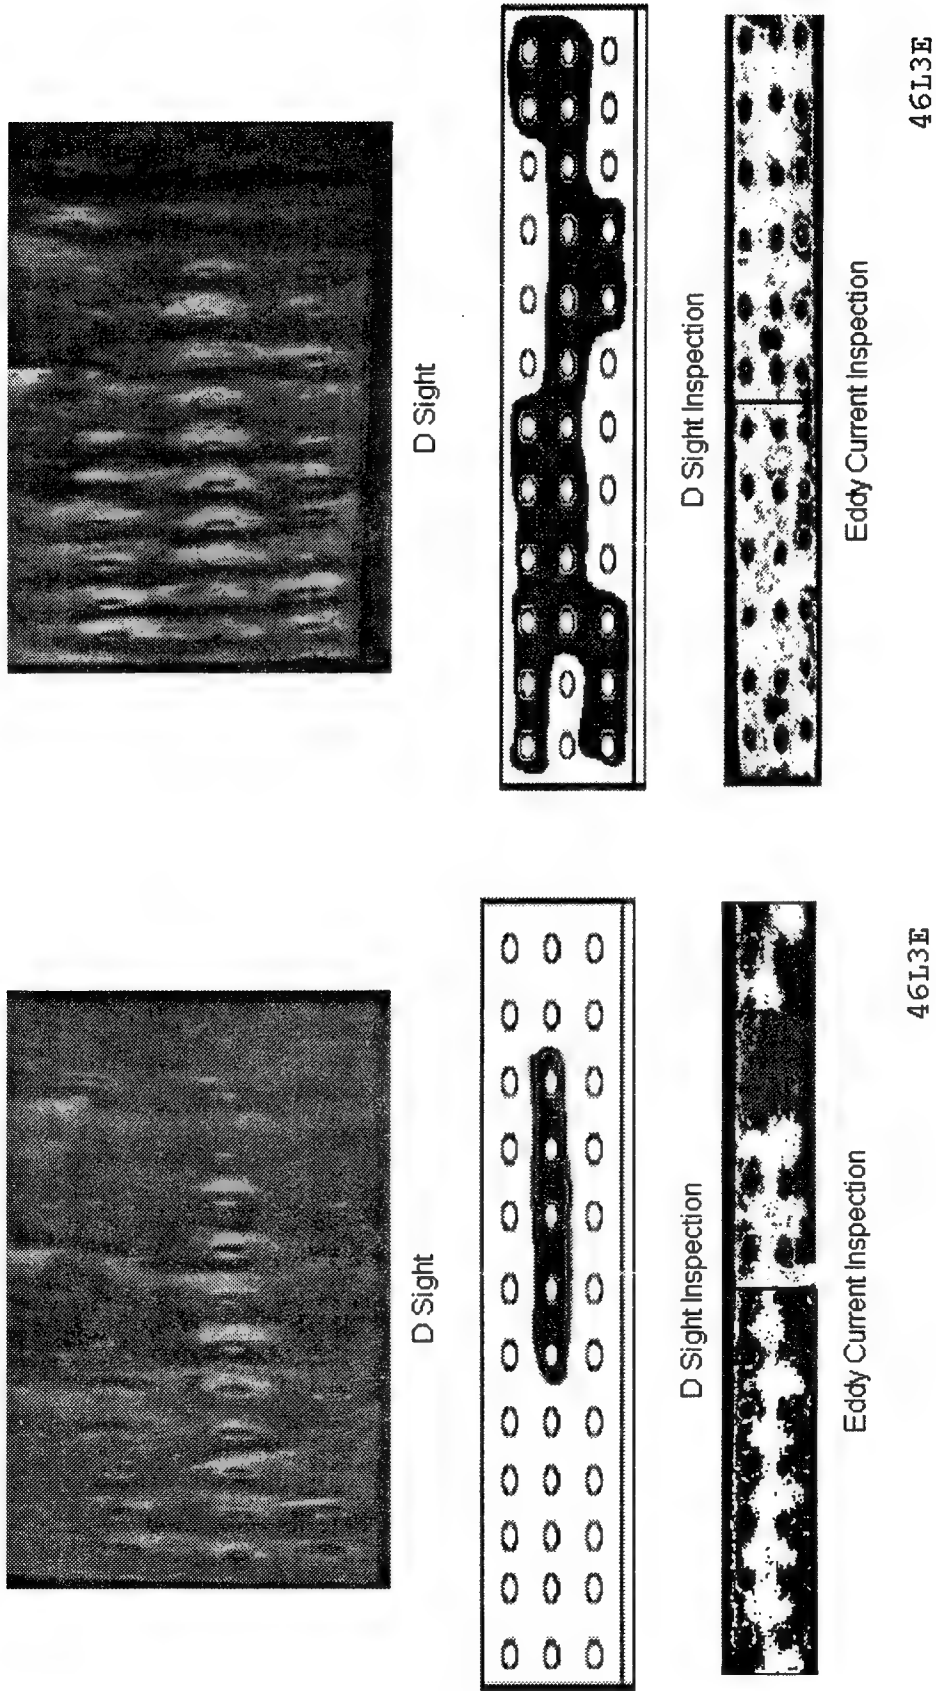
Figure 7.5 Specimen 46L3E pre- and post-corrosion inspection results. D Sight images, D Sight and Eddy Current corrosion maps.

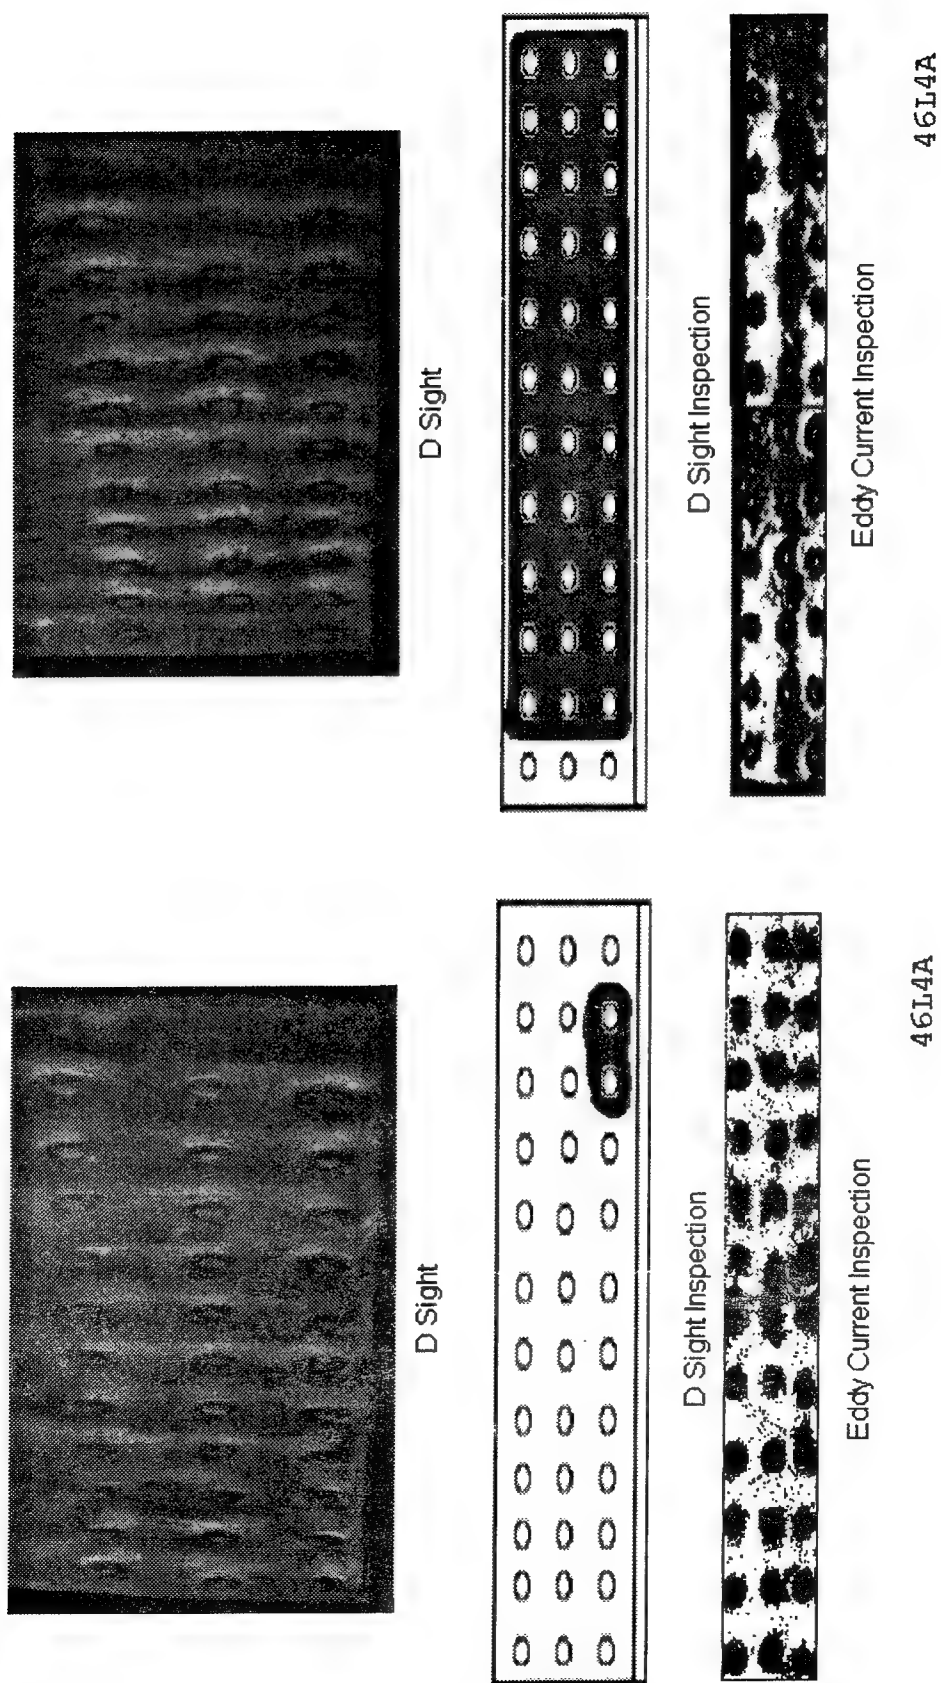
Figure 7.6 Specimen 46L4A pre- and post-corrosion inspection results. D Sight images, D Sight and Eddy Current corrosion maps.

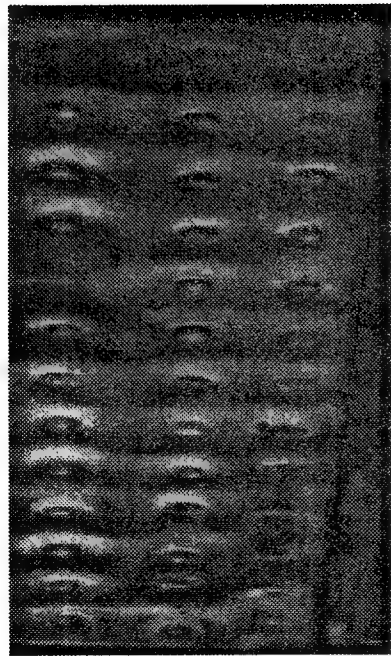
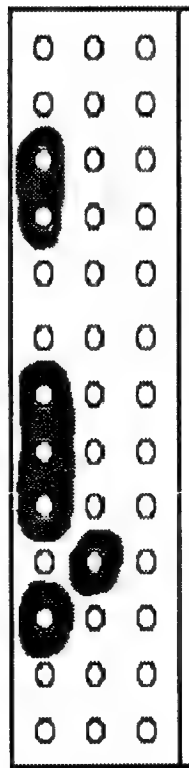
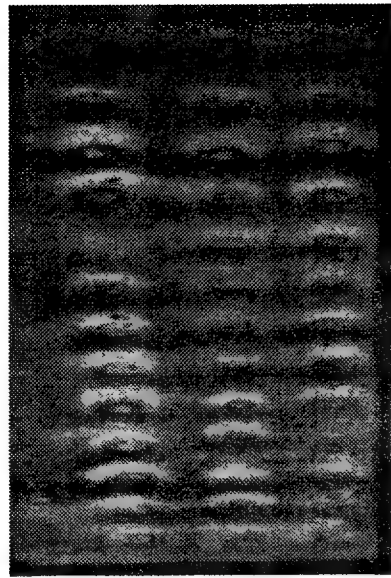
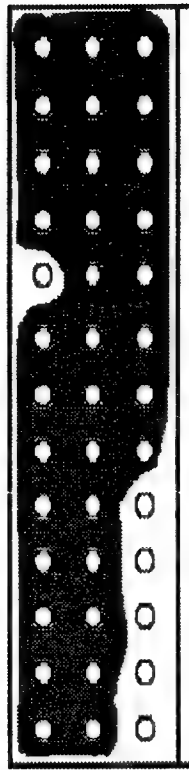
Figure 7.7 Specimen 46L4C pre- and post-corrosion inspection results. D Sight images, D Sight and Eddy Current corrosion maps.

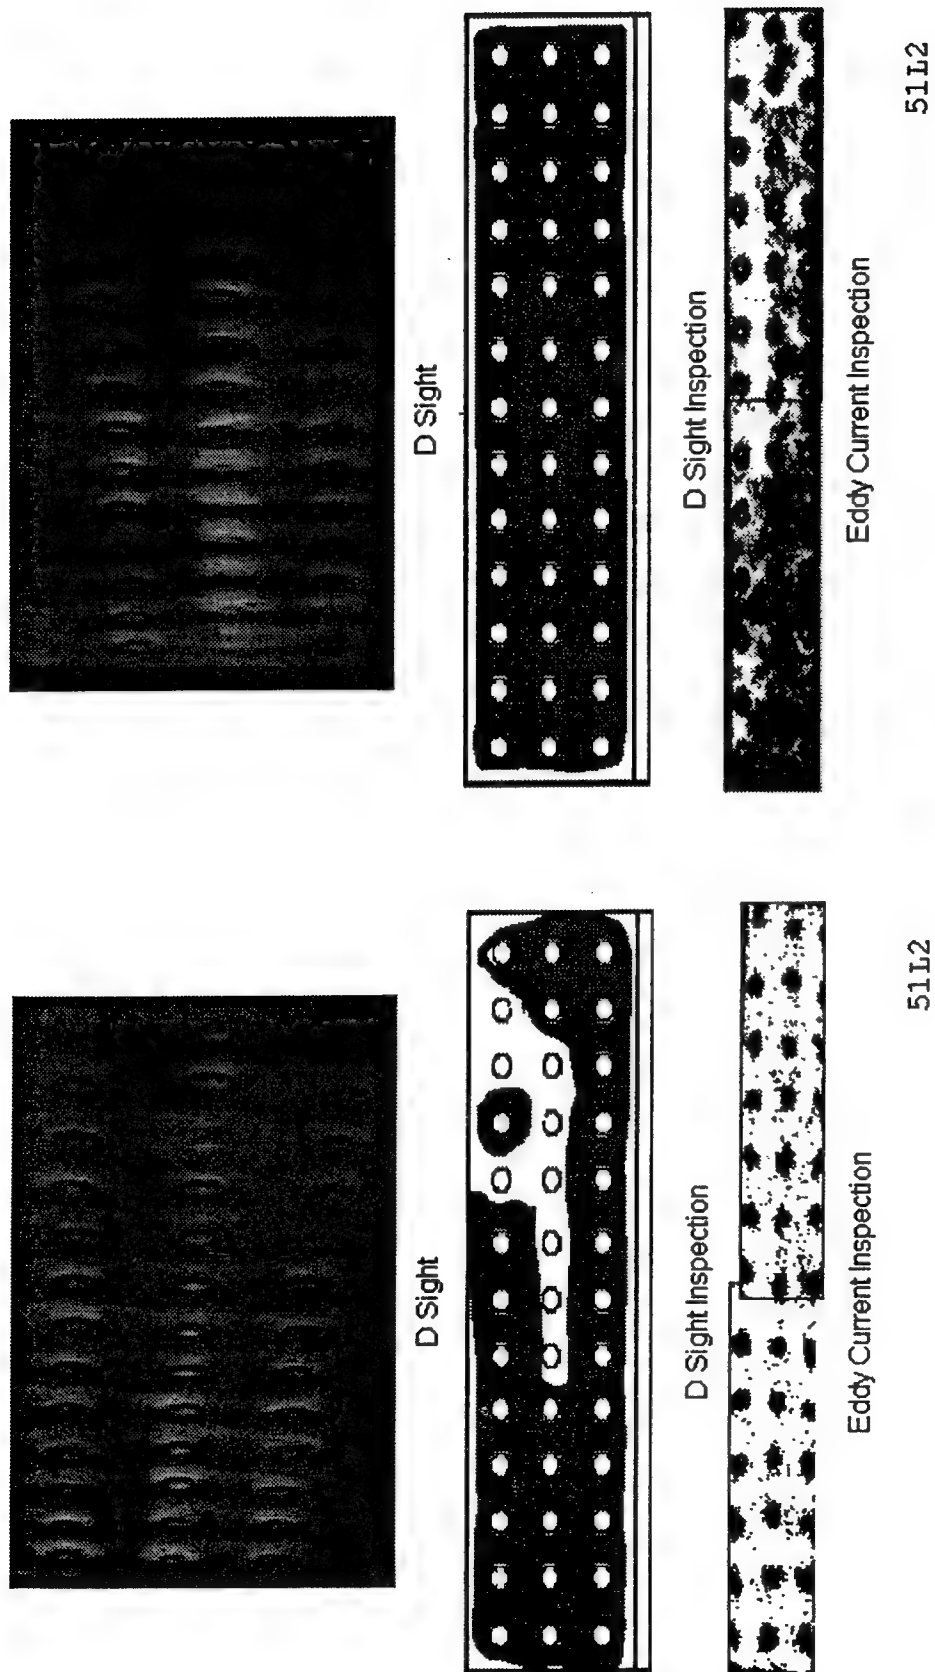
Figure 7.8 Specimen 51L2 pre- and post-corrosion inspection results. D Sight images, D Sight and Eddy Current corrosion maps.

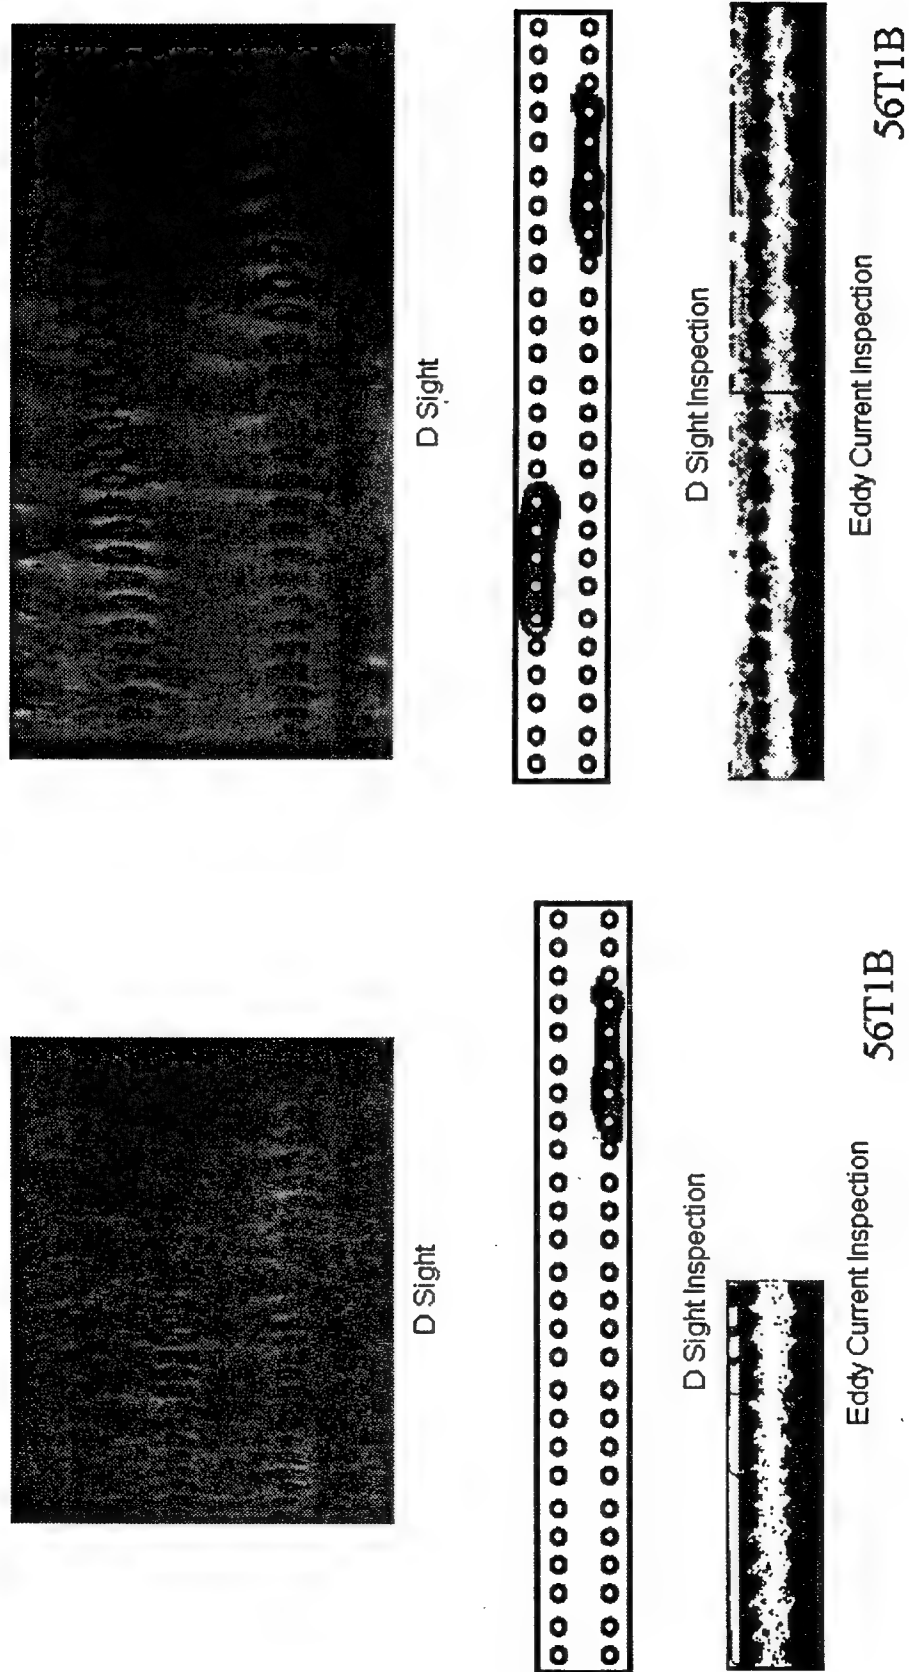
Figure 7.9 Specimen 56T1B pre- and post-corrosion inspection results. D Sight images, D Sight and Eddy Current corrosion maps.

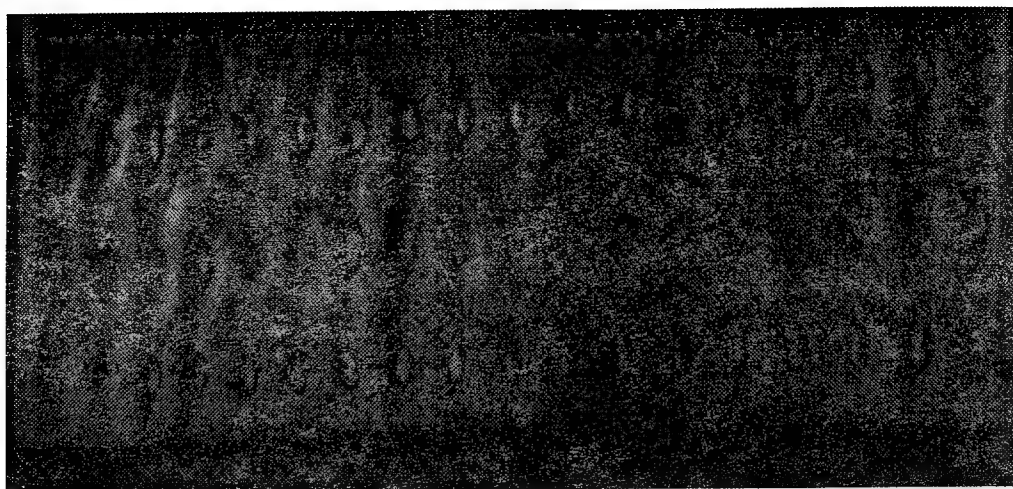
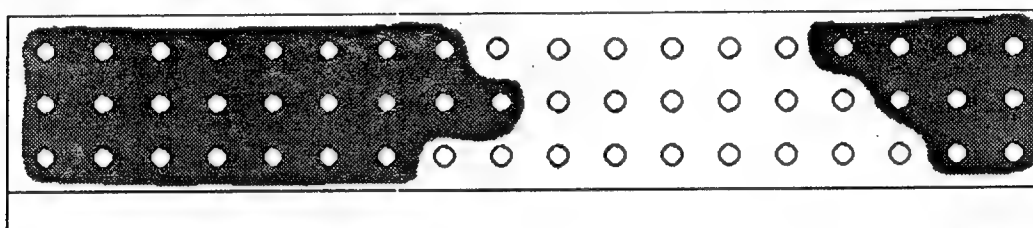
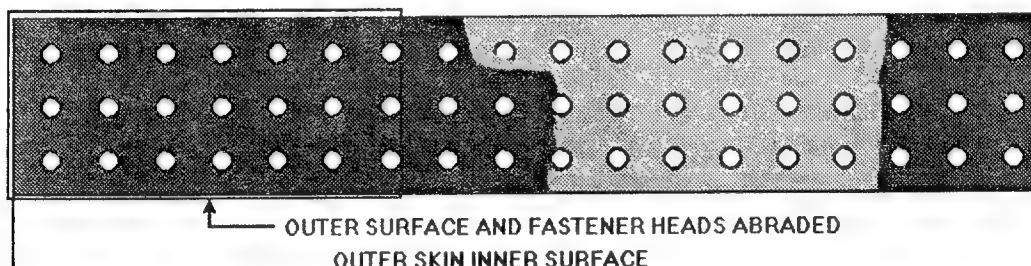
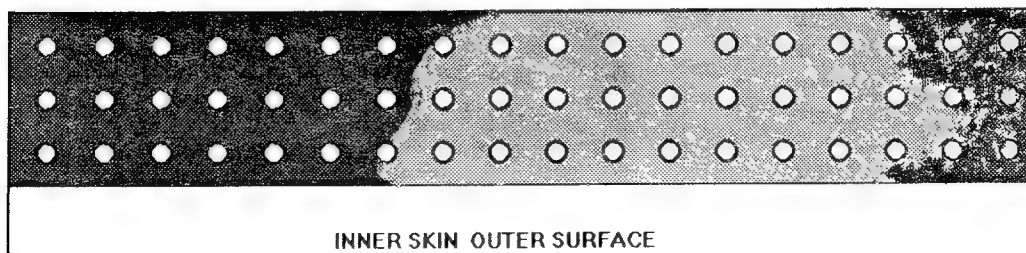
TEARDOWN INSPECTION OF SPECIMEN B727 51L1

Only two specimens were subjected to tear down subsequent to D Sight inspections and these are shown in Figures 7.10 and 7.11. In both specimens the correlation is excellent.

Figure 7.10 Specimen 51L1 D Sight and teardown maps of corrosion.

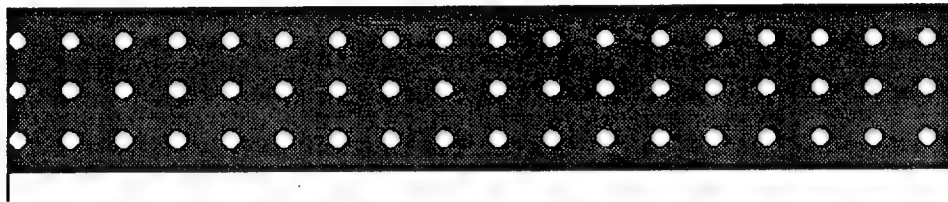
Figure 7.11 Specimen 51L6 D Sight and teardown maps of corrosion.

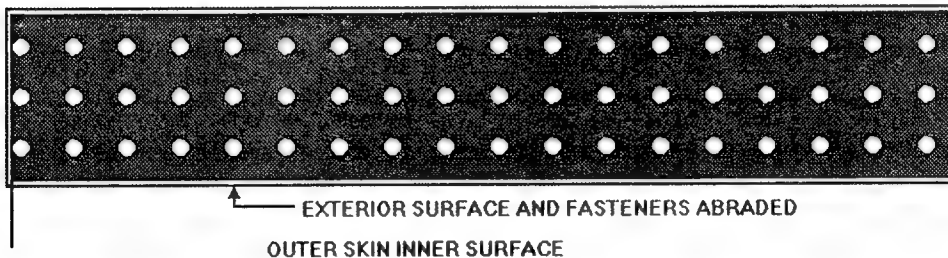
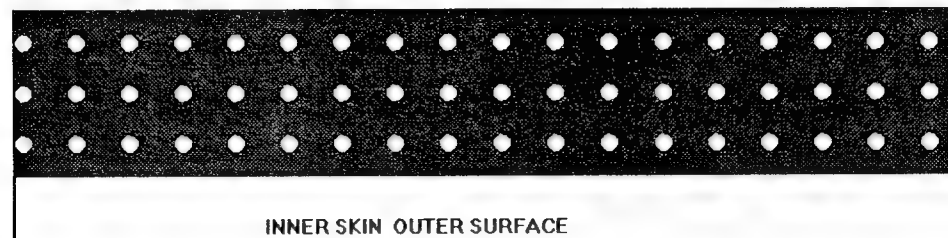
TEARDOWN INSPECTION OF SPECIMEN B727 51L6
